Performance Survey of Inflatable Dams in Ice-Affected Waters

This issue of Ice Engineering was written by Andrew M. Tuthill, Research Hydraulic Engineer, Ice Engineering Group, RS/GIS/Water Resources Branch, U.S. Army Cold Regions Research and Engineering Laboratory (CRREL), Engineer Research and Development Center (ERDC), Hanover, New Hampshire.

Ice Engineering Information Exchange Bulletin

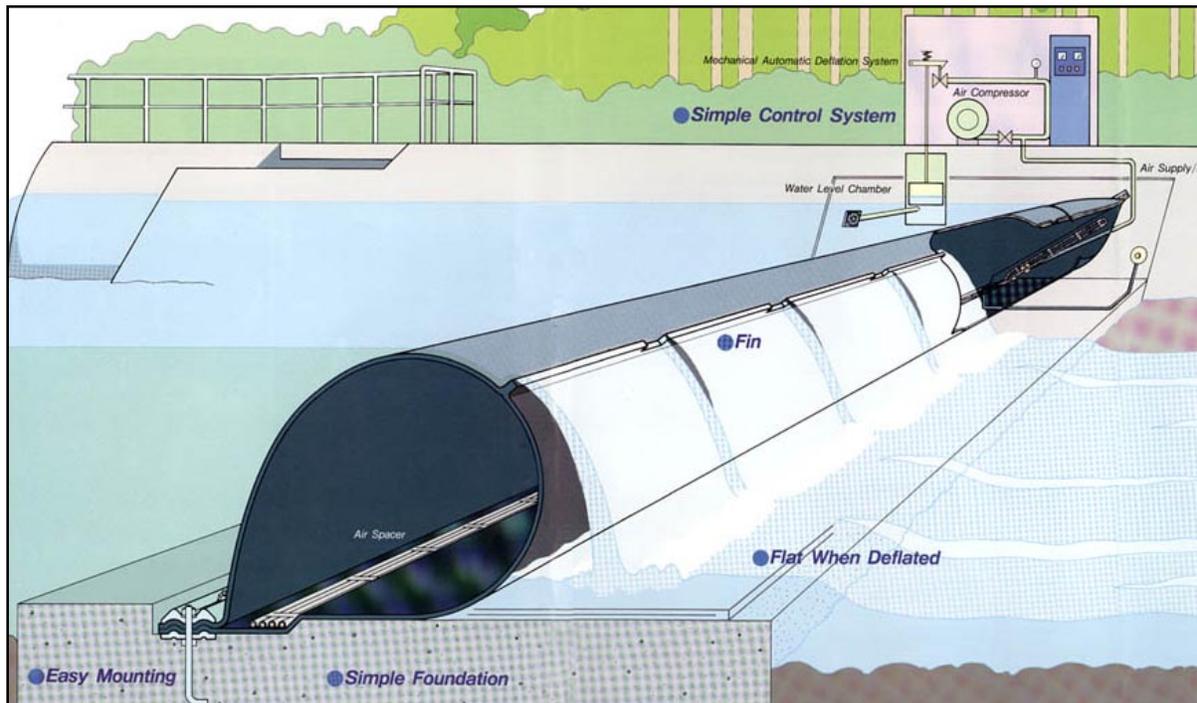
An inflatable dam consists of an air-filled tube clamped to a concrete sill (Fig. 1). The tube is made of a laminated rubber and nylon material that ranges in thickness from 10 to 25 mm, depending on the height of the dam. Inflatable dams range in height from about 0.4 to 4.6 m (1.3 to 15 ft) and the individual span lengths range from about 6 to 89 m (20 to 290 ft). The structures are best suited to situations where the width-to-length ratio is relatively high, typically greater than five.

Figure 1. Cross section of an inflatable dam.

The dams are inflated by high-volume, low-pressure compressors called “blowers” and are emptied through exhaust valves. The dam can be deflated to pass flood flows, to drain the pool, or to bypass flow during turbine shutdowns. An automatic control system operates the blowers and exhaust valves to maintain a set pool elevation or a set air pressure inside the dam. The blowers and exhaust valves also can be operated manually. When fully deflated, the rubber tube lies flat on the concrete foundation. Internal air pressure is low, varying from about 7 to 55 KPa gage (1 to 8 psi), depending on dam height. Side bulkheads and intermediate piers can be either vertical or sloping to conform to the natural side slope of the river.

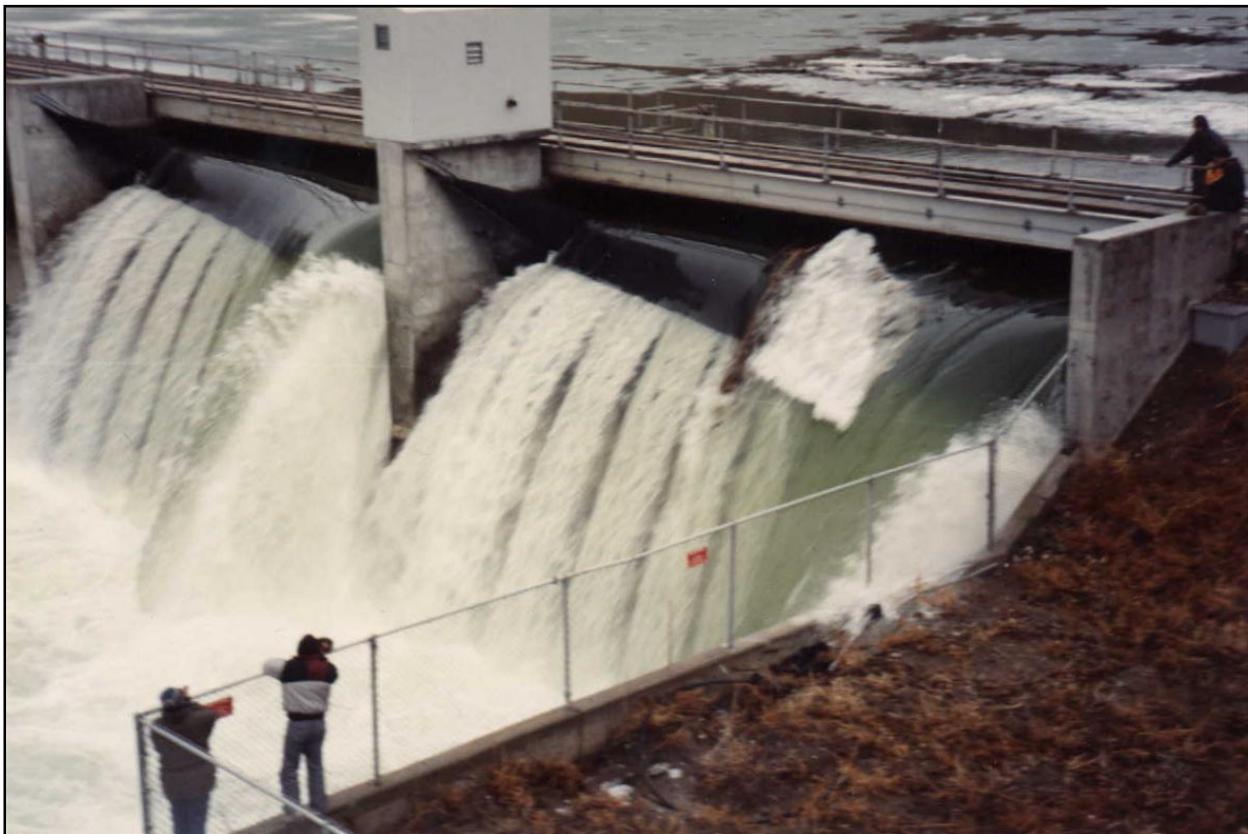
Typical winter discharge is fairly constant at about 110 m³/s (4000 cfs), and the sheet ice on the pool can reach thicknesses in excess of 0.6 m (2 ft). Ice breakup usually occurs over a two-day period in late February, during which time the river flow usually increases 50% to around 170 m³/s (6000 cfs). During breakup, large ice floes, trees, pieces of washed-out bridges, and telephone poles (wires and all) pass over the air bags on the dam. Long pieces of debris sometimes lodge between the concrete piers and must be dislodged using long poles, or cut in half with chainsaws. The ice-out is usually followed by a rainy season with higher open water flows. During the maximum flow experienced since installation, 1080 m³/s (38,000 cfs), the air bags were completely deflated.

Some of the air bags leak in the crease areas near the concrete bulkheads. Also, leaks in the upstream and downstream faces of one airbag resulting from a high-powered rifle round were mended using a tubeless tire repair kit. Brian Carroll, who has been at the project since the installation of the inflatable dam, is very pleased with its performance.

Figure 2. Ice and debris passing over Broadwater Dam on the Missouri River at Townsend, Montana. Note the vee notch in the airbag near the land-side bulkhead.

Vee-notch formation while spilling water has potential drawbacks. The first is that concentration of flow downstream of the dam may result in scour and possible foundation damage. Also, with an uneven crest height, it is difficult to estimate the depth of flow over the dam, and the water discharge being spilled.

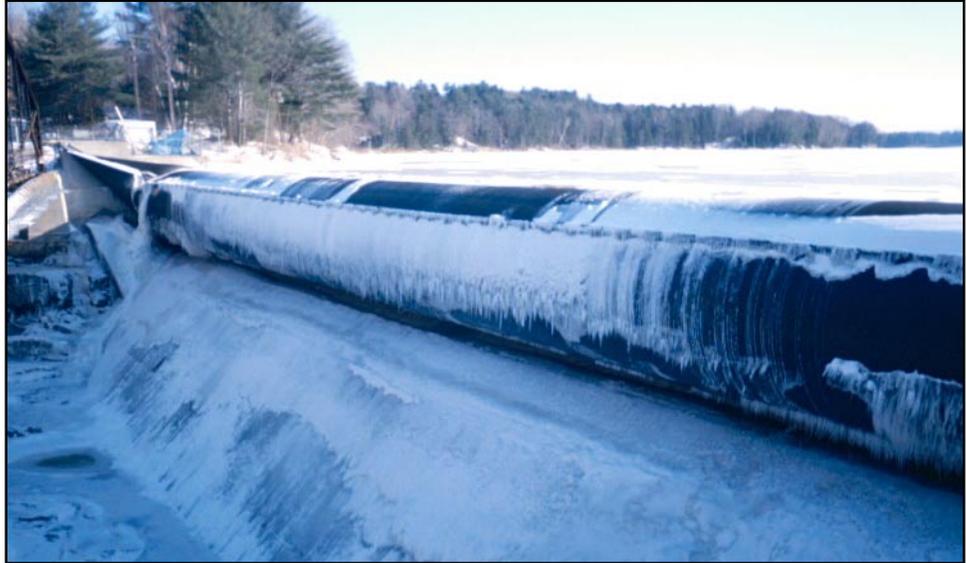
A 4.6-m-high by 67-m-long (15-ft by 220-ft) Bridgestone inflatable dam regulates pool elevation at a 9.8-MW hydroelectric plant owned by the village of Swanton, Vermont, on the Missisquoi River at Highgate Falls. Figure 3 shows the dam in its fully inflated configuration. Plant Manager Alan Mosher describes the new dam as a godsend in terms of reducing ice problems.

The 1992 construction of the Highgate Falls inflatable dam, on a 5-ft-high concrete sill, raised pond elevation by a total of 6.1 m (20 ft). It is one of the highest in existence, and it is possible to walk inside for inspection and repair purposes. When fully inflated, the inside air pressure is 52 KPa gage (7.5 psi). The dam is constructed of 18-ply rubber about 25 mm (1 in.) thick.

Figure 3. Highgate Falls Dam, fully inflated, 21 January 2000.

The higher pool allowed the area of the hydroelectric intakes area to be doubled, reducing water velocity near the trash racks. The frazil ice blockage problems that existed before the raising of the pool were solved, and debris collection problems minimized. Breakup ice runs passed over the old dam, often destroying the wooden flashboards. Setting and maintaining the flashboards was time-consuming and, to some extent, risky. With the inflatable dam, flashboards are no longer necessary. Before the inflatable dam was installed, breakup ice runs were a problem. In addition to damaging the flashboards the hydroelectric plant downstream of the dam was inundated in 1979 as the result of a breakup ice jam. In March 1992 a severe breakup ice run damaged the structural steel in the footings to the new dam while under construction. With the inflatable dam, it is possible to minimize stage rise in the head pond during breakup by progressively lowering the crest height of the dam as river flow increases. This practice helps preserve the intact sheet ice cover, often allowing it to melt in place rather than break up and move downstream as in the past. Mosher has witnessed ice blocks as thick as 1.2 m (4 ft) passing over the dam crest. He said that at times large ice pieces or floes will hang up on the dam, requiring a temporary lowering of the crest height to get the ice moving again.
